Dutch East India Company Shipbuilding

THE ARCHAEOLOGICAL STUDY OF
BATAVIA AND OTHER SEVENTEENTH-
CENTURY VOC SHIPS

Wendy van Duivenvoorde

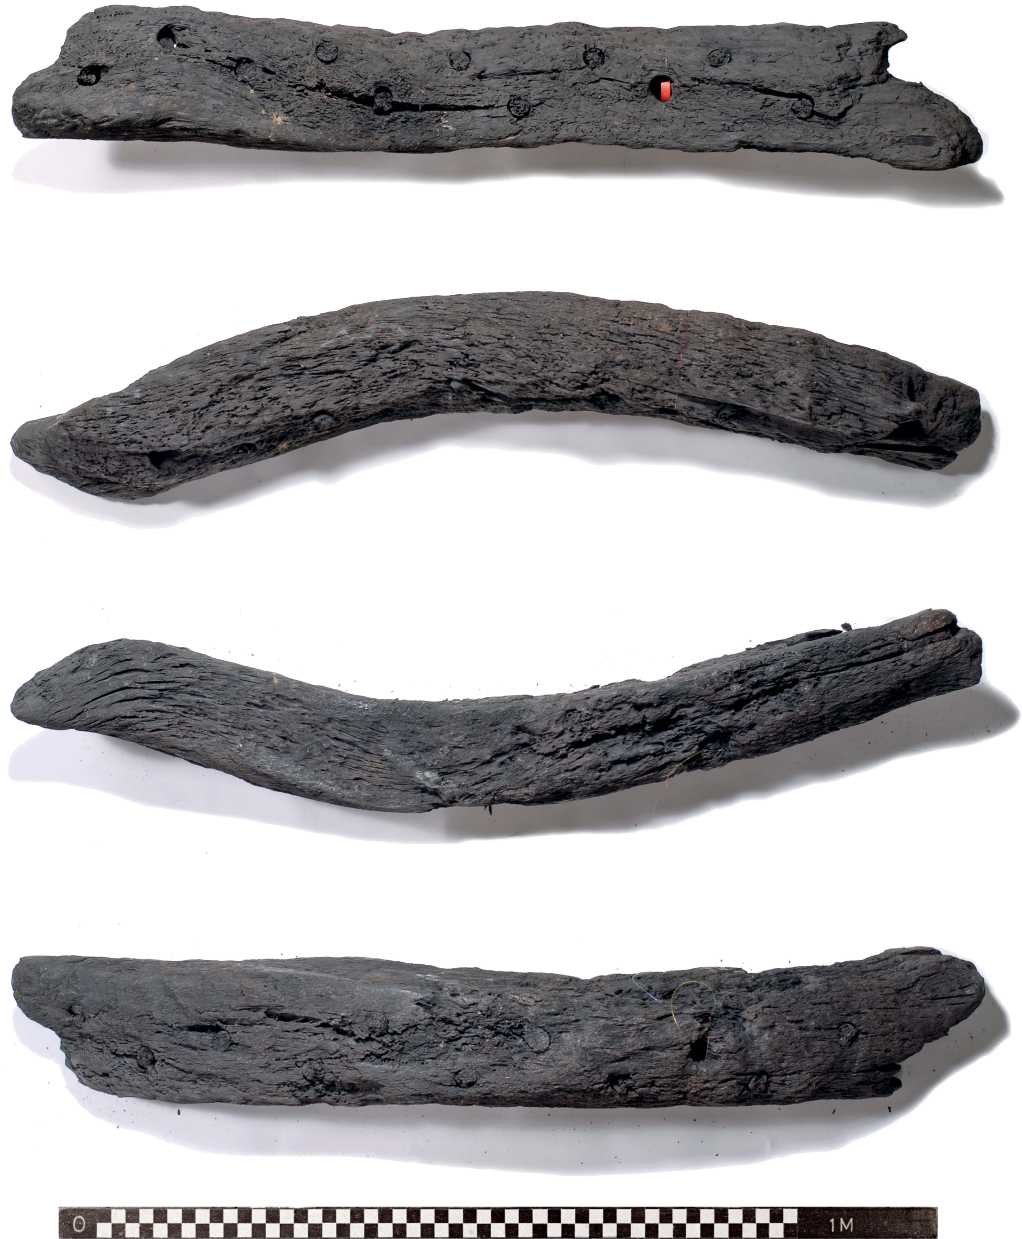
FIGURE 5-25.
Frame timber from VOC
ship *Vergulde Draak*, GT
6164. Photographs by
Patrick Baker, Western
Australian Museum.

Like *Vergulde Draak*'s planking, none of its frame timbers are preserved over their entire length or width, and the largest fragment has a maximum length of 1.44 m, a maximum sided dimension of 20.5 cm, and a molded dimension of 16.5 cm (GT 6164). Two treenails have been observed that are wedged with a small wedge (both 7 mm in thickness) on the interior surfaces of two frame timbers (GT 6171 and GT 6185).

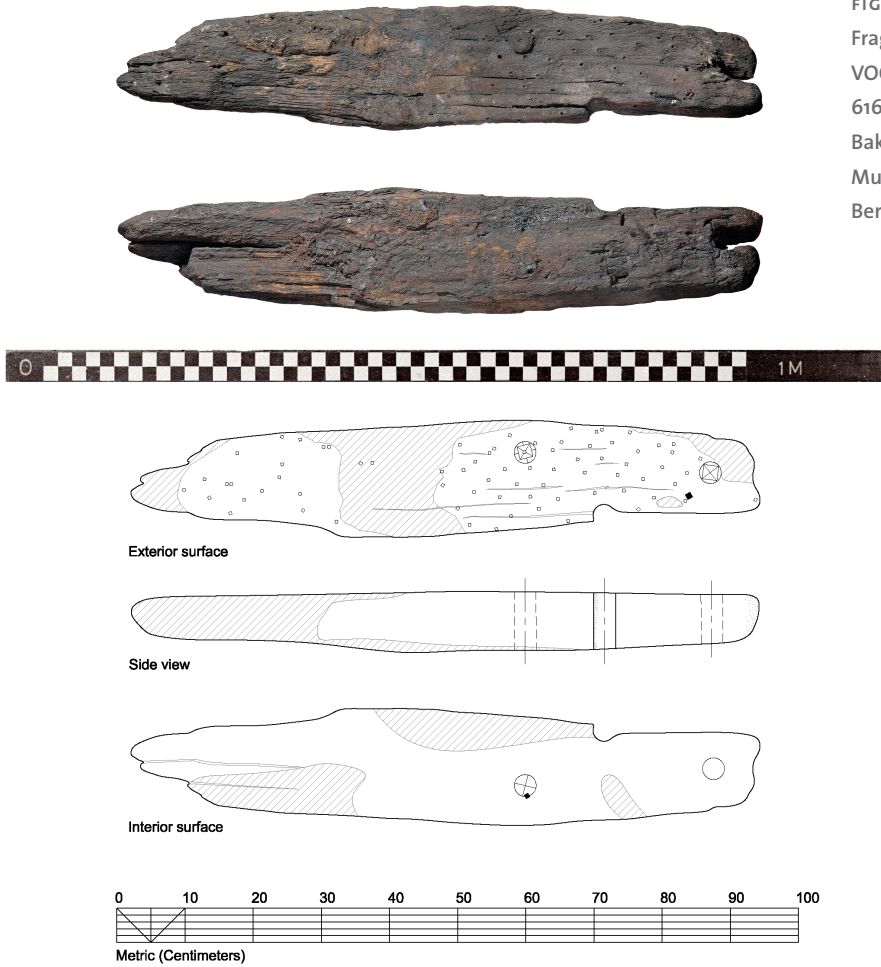
FIGURE 5-26.

Fragment of hull plank from VOC ship *Vergulde Draak*, GT 6166. Photographs by Patrick Baker, Western Australian Museum. Illustration by Jessica Berry and author.

The better-preserved fragments of *Vergulde Draak*'s hull planking all have closely spaced nail holes on their exterior surfaces, 4 to 7 cm apart, in a quincunx pattern. The nail holes were left behind by iron filling nails that would have fastened the ship's pine sheathing to the hull planking; the nails had square shanks with an average cross section of 4 to 5 mm (see fig. 5-26).

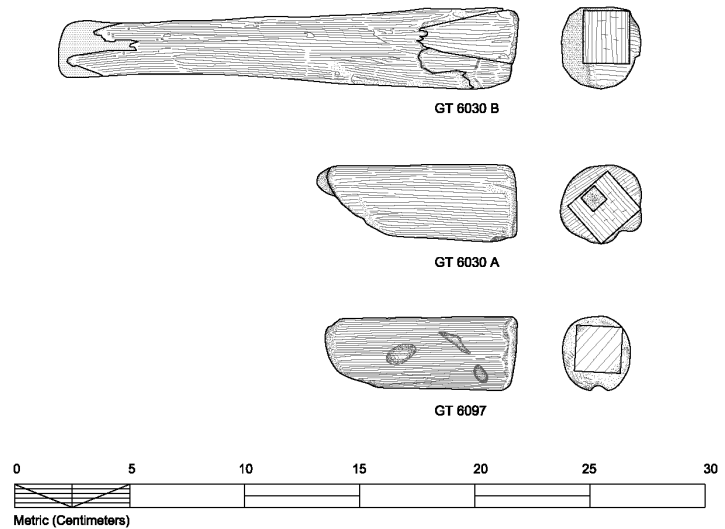
FIGURE 5-27.
Pegged treenails from
VOC ship *Vergulde Draak*.
Illustration by author.

No examples of complete treenails from *Vergulde Draak* have been found that are preserved over their entire length. The longest preserved treenail, not seated in a timber, is 20.5 cm and is pegged with a square peg on its intact end (fig. 5-27, GT 6030 B). To date, 22 pegged treenails and 3 treenail pegs have been identified, and, if still seated in hull planking or have filling nail holes preserved, they indicate that their pegs were driven into the treenails on the planking's exterior surface (see figs. 5-26 and 5-28). The pegs have an average width of 2 cm at their top surface; they taper to a point over an average length of 4.6 cm (maximum 1.5 cm).

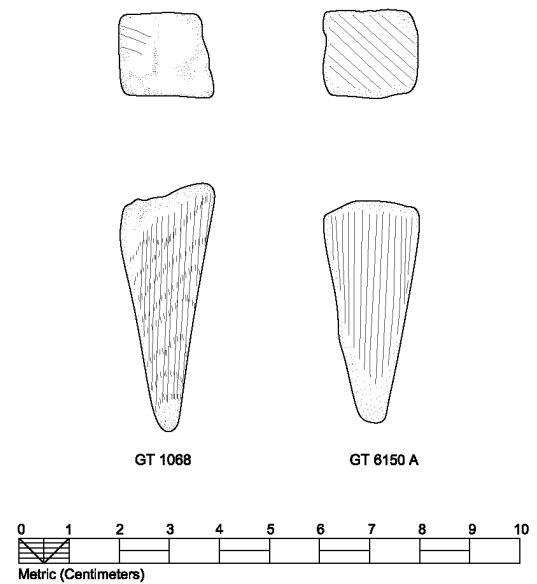
FIGURE 5-28.
Treenail pegs from VOC ship *Vergulde Draak*.
Illustration by author.

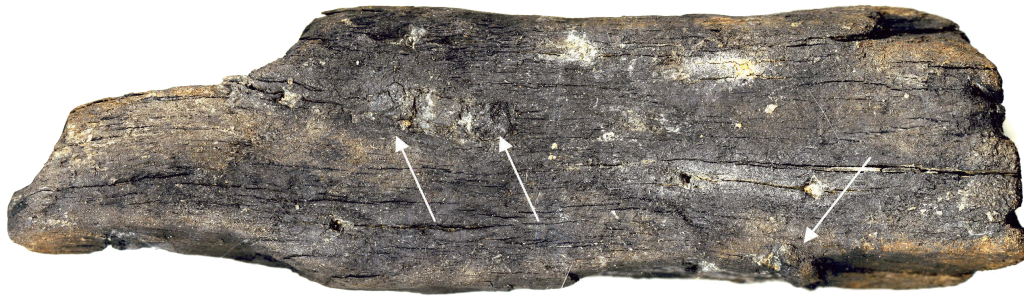
FIGURE 5-29.
Fragment of hull
planking of VOC ship
Vergulde Draak, GT 6142
P. Location of nail plugs
indicated by arrows.
Photographs by author.

exterior faces (fig. 5-29). One oak nail plug was removed from hull plank GT 6167; it is preserved over a length of 2 cm and has a maximum cross section of 6 mm (fig. 5-30). Generally, *Vergulde Draak*'s nail plugs vary in length between 2 and 3 cm and have an average width of 8 mm at their top surface.

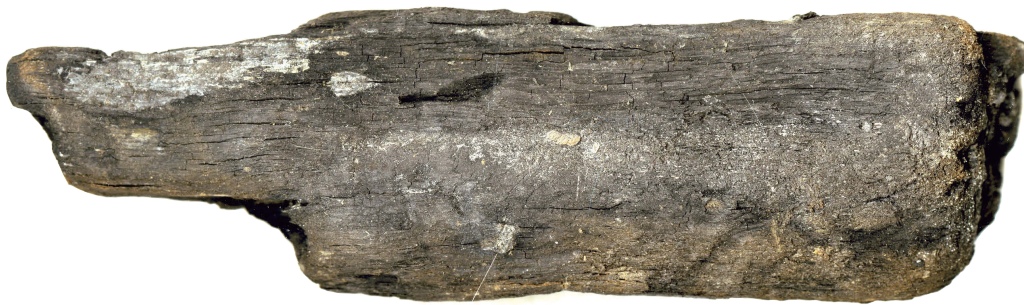
FIGURE 5-30.
Nail plug from VOC ship
Vergulde Draak, GT 6167.
Illustration by author.

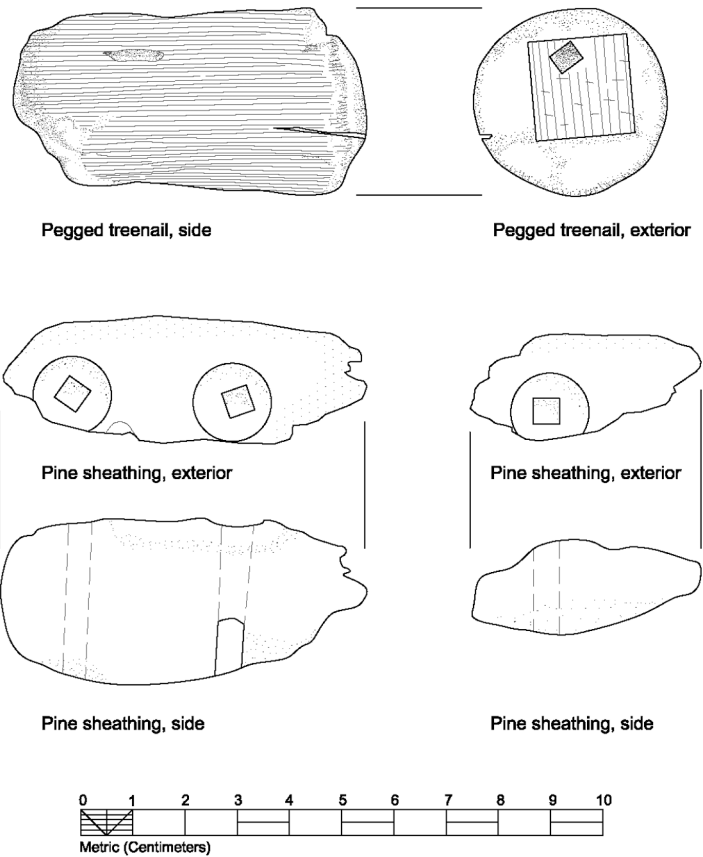
FIGURE 5-31.

Pegged treenail and two fragments of pine sheathing from VOC ship *Zuiddorp*, ZT 4022. Illustration by author.

pegged treenail and two fragments of pine sheathing (fig. 5-31). This pegged treenail still retains the nail hole of a filling nail, indicating that it was used to fasten the frames to the hull planking (or vice versa) and was pegged at the exterior surface of the hull planking. It also suggests that the ship was built with one layer of oak hull planking. Certainly, the presence or lack of treenails is not sufficient evidence for a specific construction method.

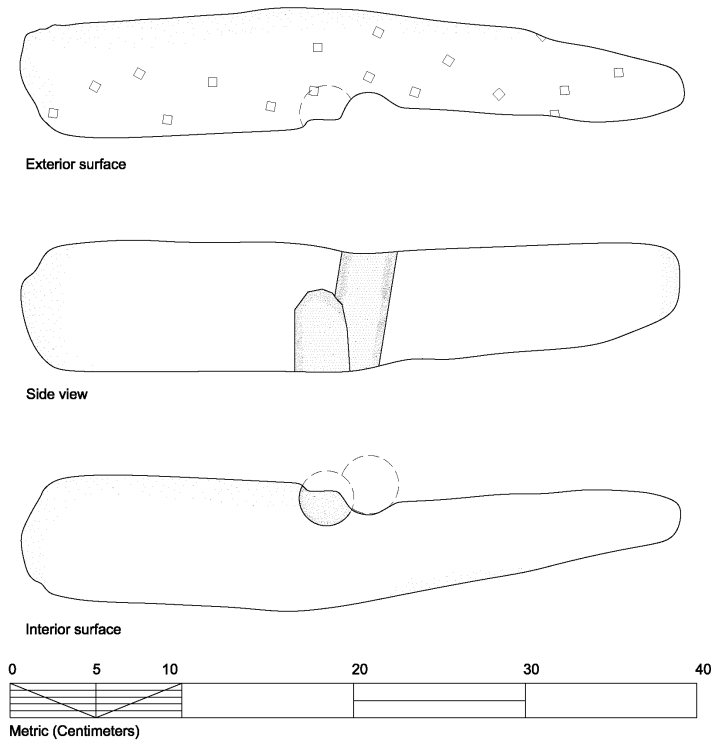
FIGURE 5-32.

Fragment of hull plank from
VOC ship *Vergulde Draak*, GT
1386 C. Illustration by author.

Several blind treenails found on the interior surface of the hull planking and frames indicate that treenails were used to fasten the ceiling planking to the frames and hull planking (fig. 5-32).¹⁰⁴ Generally, these blind treenails seem to be slightly smaller in diameter than the ones used to fasten the frames to the hull planking, as they vary in diameter between 2.7 and 3.1 cm, with an average of 3 cm.

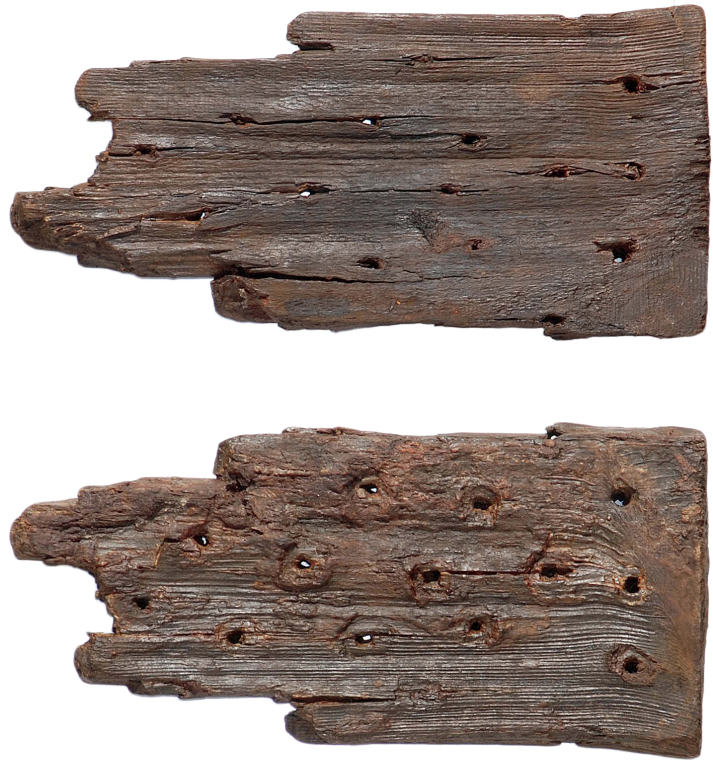
FIGURE 5-33.
Fragment of pine sheathing
showing mechanical saw
marks on lower right corner of
interior surface (*top*) from VOC
ship *Vergulde Draak*, GT 6020.
Photographs by Patrick Baker,
Western Australian Museum.

Eight fragments of pine sheathing clearly show mechanical saw marks, which were mainly preserved near knots where the wood is harder (figs. 5-33 and 5-34).¹⁰⁵ The saw cuts of all these planks are 1.5 mm apart, which is the distance to be expected for seventeenth-century wind-driven sawing when sawing was performed by setting the mill's scroll wheel to two teeth per stroke (figs. 5-35 and 5-36).¹⁰⁶ Simon Jellema, miller of a still-operational wind-driven sawmill, De Rat, in IJlst in the Netherlands, that dates from the seventeenth century, explains that the timber is placed on a sled that is pulled through the mill's sawing frame. The mechanism that pulls the sled can be set to a specific speed that influences the distance between the saw marks. With every wind-driven stroke of the mill, a *haler* draws this preset number of teeth through the mill's scroll wheel, which then pulls the sled through the saw frame. The number of teeth per stroke can thus be regulated. On average, the movement of the sled is 0.6 to 0.7 mm per stroke (by one tooth), which is

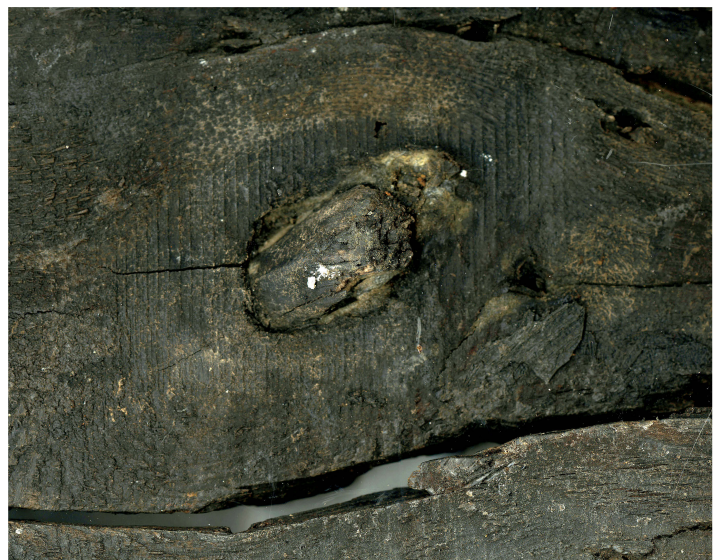
FIGURE 5-34.
Detail of pine sheathing from
VOC ship *Vergulde Draak*
showing mechanical saw
marks, GT 1389 C. Photograph
by author.

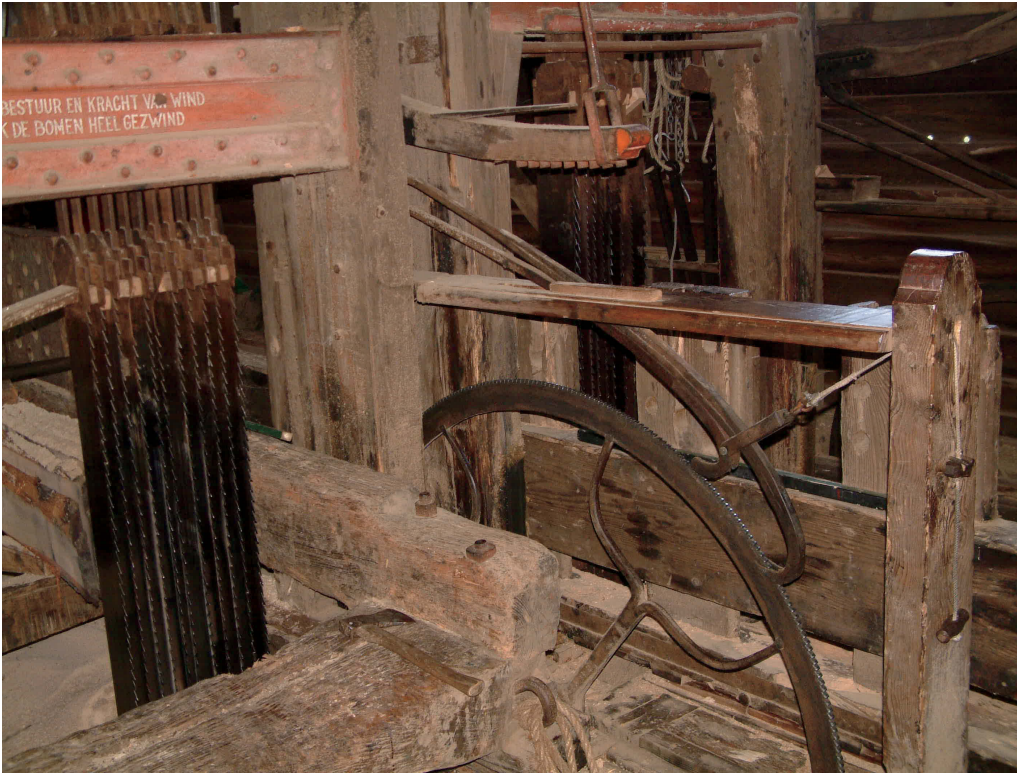
FIGURE 5-35.
Sawing blades of a still-operational wind-driven sawmill (originally built before 1683), De Rat, in IJlst, Netherlands. Photograph by Simon Jellema, miller of De Rat.

relatively slow. Jellema prefers to saw slightly faster, two teeth per stroke, as was done in the past. He states that this tuning should provide a distance between the saw marks of 1.5 mm. The *Vergulde Draak* timbers support his theory.

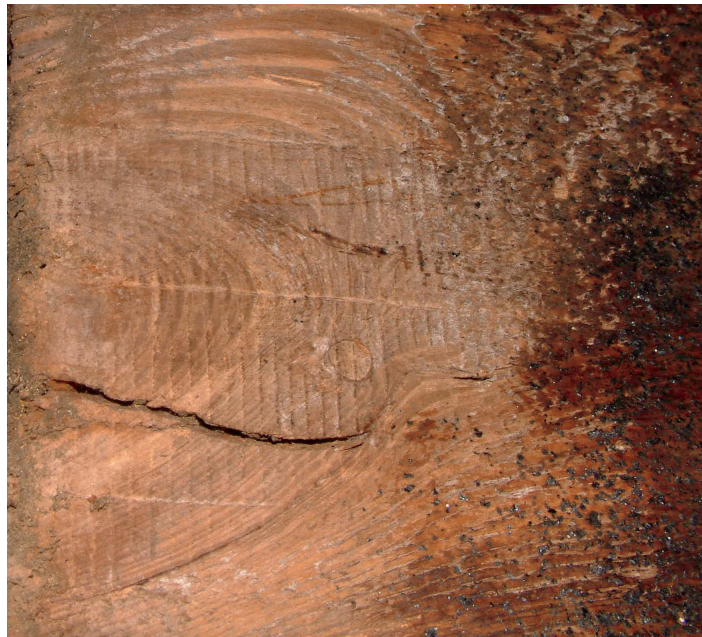
FIGURE 5-36.
Saw marks on pine joist used in the construction of the sawmill De Rat in IJlst, Netherlands, sawn mechanically by wind-driven sawmill (17 saw marks per 0.010 m), dating to 1683 or earlier. Photograph by Simon Jellema, miller of De Rat.

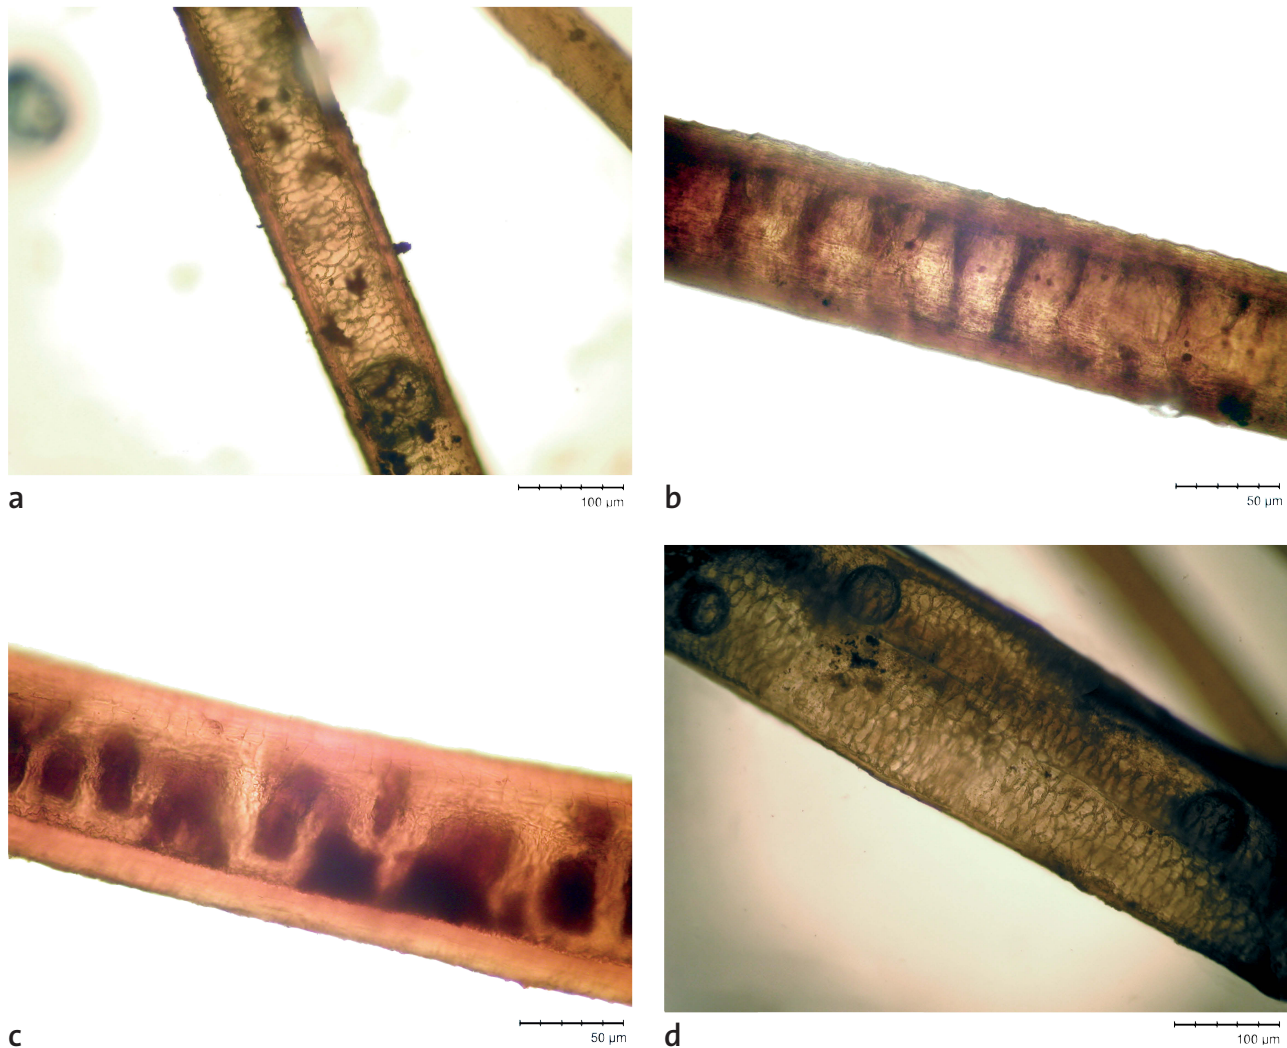
FIGURE 5-37. Goat and cattle hair from *Vergulde Draak* (a, b, c) and *Zeewijk* (d) shipwrecks as seen through a dissecting microscope. (a) “Honeycomb lattice” or “scalloped type” medulla of goat hair sample (200×), GT 98 B. (b) Cattle hair (400×), GT 61. (c) Another strand of cattle hair (400×), GT 61. (d) “Honeycomb lattice” or “scalloped type” medulla of goat hair sample (200×), ZW 5602. Micrographs by Mark van Waijjen, BIAAX Consult.

on the ship’s pine sheathing have recently been identified as goat hair and one as cattle hair (fig. 5-37a–c; table 5-3).¹⁰⁷ In addition to the seventeenth-century hair samples of *Batavia* and *Vergulde Draak*, a sample of animal hair removed from the pine sheathing of the eighteenth-century *Zeewijk* (ZW 5602) was also identified as goat hair (fig. 5-37d). The *Vergulde Draak* hair identified as being from cattle consists of primary guard hairs, which clearly show the diagnostic marker for cattle hair, the so-called globular vacuoles.¹⁰⁸

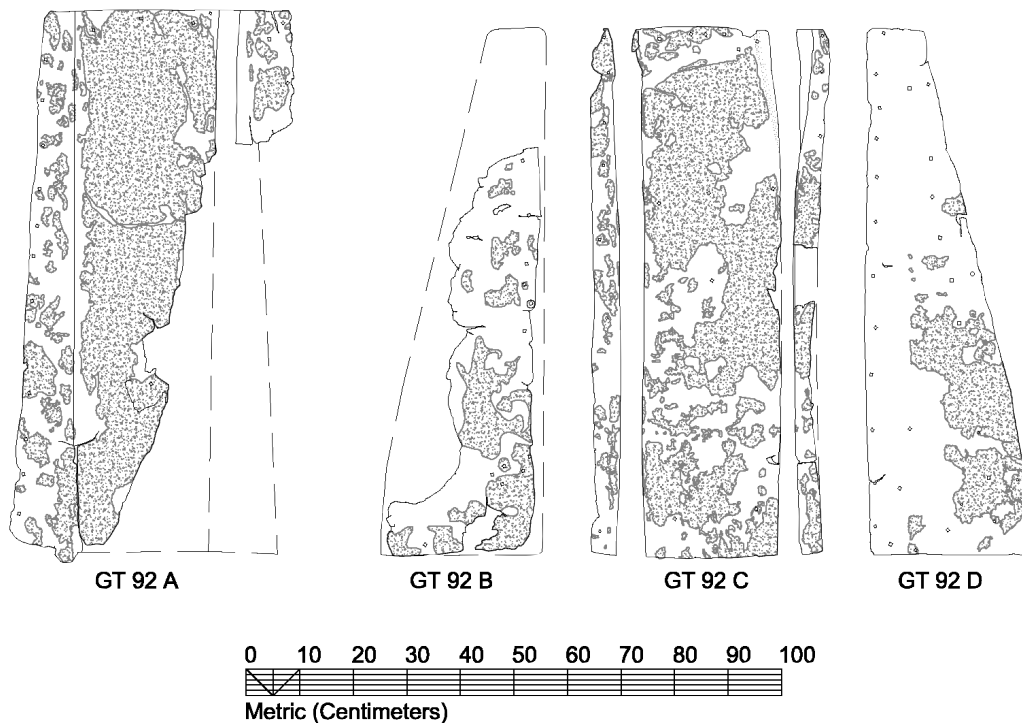
FIGURE 5-38. Exterior surfaces of copper sheets, possibly from *Vergulde Draak*'s sternpost sheathing, GT 92 A–D. Illustration by author.

A total of 18 sheets of copper have been identified as sternpost sheathing from *Vergulde Draak* (GT 91, GT 92, GT 1442, and GT 3169). An isometric reconstruction drawing of the sternpost copper sheets has been previously published.¹⁰⁹ Two sets of these copper sheets (one with a lead lining) that make up 8 of the 18 sheets are discussed later. Recent study of a set of 4 copper sheets has demonstrated that 2 sheets nailed on the sternpost's aft face covered 1 copper sheet on each side of the sternpost (fig. 5-38).

The outer layer of copper sheathing (GT 92 A) measures 1.03 m in length and 29.4 cm in width at its aft face (one side has a width of 6.5 to 13.5 cm, and the other, 9 cm). The inner layer (GT 92 C) measures 98.5 cm in length and 25.1 cm in width (plus 4.0 to 4.5 cm

for each side). One of the side sheets is preserved well (GT 92 D); it is 98.2 cm in length and tapers from 11.5 to 31 cm in width. The other side is preserved over a length of 75.8 cm and has a maximum width of 27.2 cm. All sheets have a maximum thickness of 3 mm, and the cross sections of the square shanks of the sheathing tacks vary from 4 to 6 mm. No sheathing tacks have been preserved in association with these sheets.

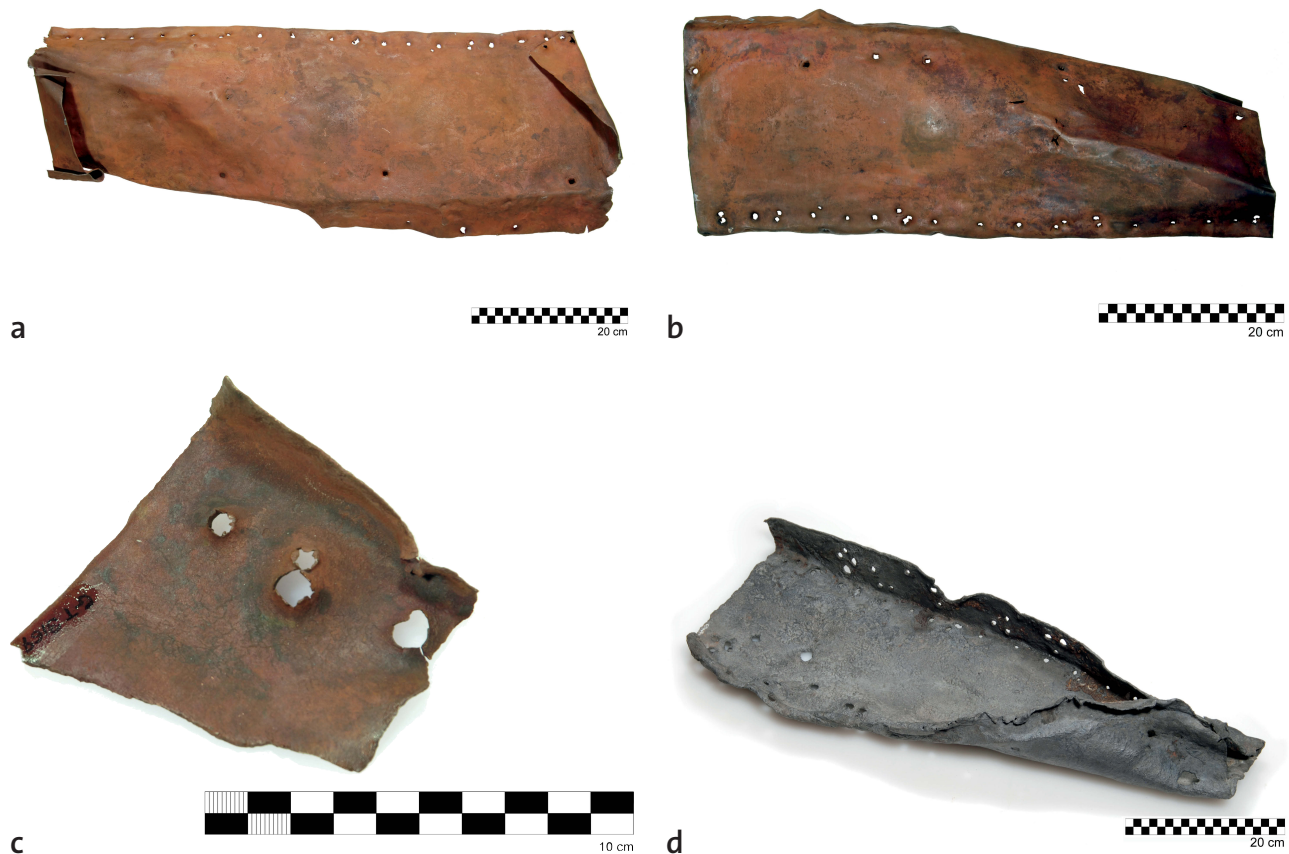
FIGURE 5-39. Copper and lead sheathing, presumably from *Vergulde Draak*'s sternpost. (a) Exterior of outer layer, copper, GT 3169 A. (b) Exterior of inner layer, copper, GT 3169 B. (c) Adjustment patch placed between the side of the inner and outer layers of copper sheathing, GT 3169 C. (d) Interior of innermost layer, lead, GT 1442. Photographs by Patrick Baker, Western Australian Museum.

In addition to this set of copper sheets, another set of multiple layers of copper sheathing with a lead lining from the sternpost has been recovered from the shipwreck site. This sheathing consists of two copper sheets that fit together and collectively form an outer layer of sheathing (figs. 5-39a–c) that is nailed over a layer of lead sheathing (fig. 5-39d).¹¹⁰ The outermost layer of copper sheathing (GT 3169 A) measures 78 cm in length (of which the lowest 5 cm is bent) and 23 cm in width and has a maximum thickness of 3 mm. The layer of copper sheathing between the outermost layer of copper and innermost layer of lead (GT 3169 B) measures 62.5 cm in length, is 22.5 cm in width (plus a few centimeters for each side strip), and has a maximum thickness of 3 mm. The lead sheet measures 70.5 cm in length, 22 cm in width at its aft face (plus 6 cm in width for each side strip), and 5 mm in thickness.

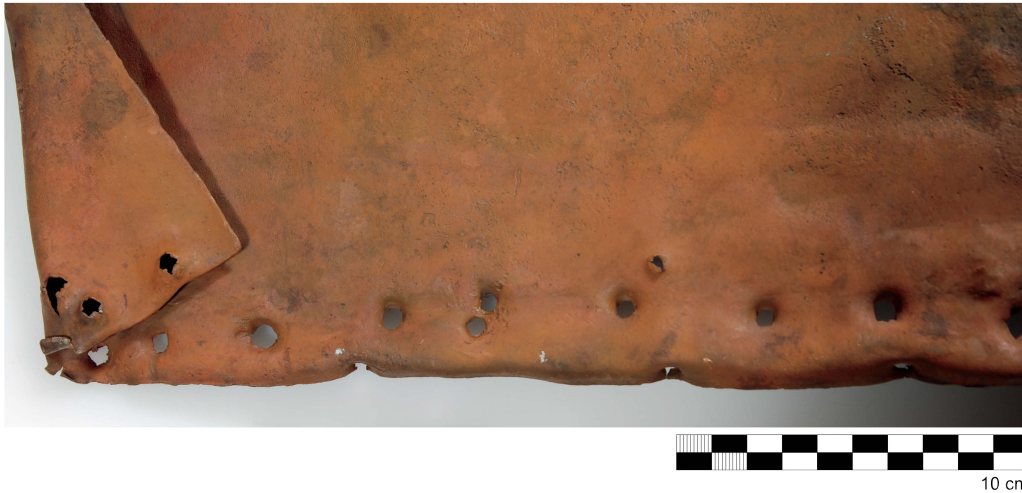
FIGURE 5-40.
Detail showing
sheathing nail holes
along edge of exterior
of outer layer of
copper sheet, *Vergulde
Draak's* sternpost, GT
3169 A. Photograph by
Patrick Baker, Western
Australian Museum.

The number and arrangement of the nail holes indicate that the lead sheathing was nailed onto the sternpost or rudder first, then one layer of copper sheathing was fastened on top, followed by a second layer of copper sheathing. The nail holes on all sheets clearly indicate the interior and exterior sides of all pieces, as the metal curls inward in the direction the nails were hammered (fig. 5-40). Furthermore, a few nail head impressions are preserved on their exterior surfaces. The impressions indicate that the nail heads vary from 1.4 to 1.6 cm in diameter, whereas the nail holes show that the cross-sectional dimension of the nail shanks varies between 4 and 6 mm in width.

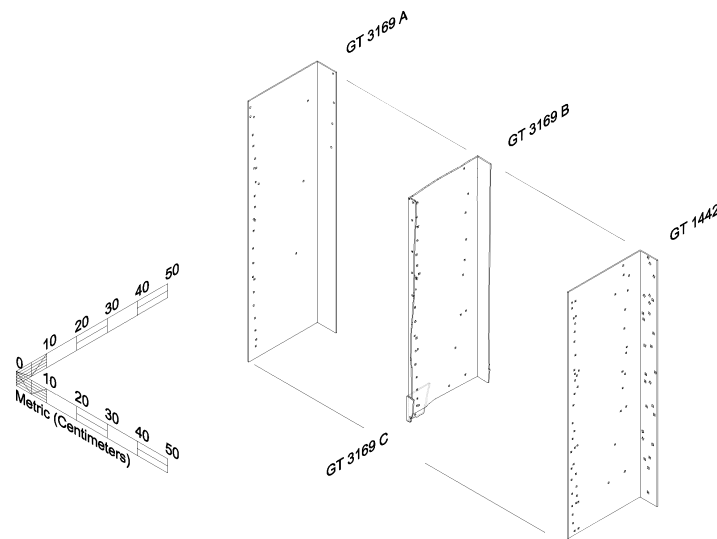
FIGURE 5-41.
Reconstruction of
multiple layers of
Vergulde Draak
sternpost sheathing.
Illustration by author.

The copper and lead sheets cover the entire aftermost face of the stern post and curl around to the sides of the timber for several centimeters (the sides of the lead sheathing have a maximum width of 6 cm). The lead sheathing was fitted better around the post than the copper sheets, which were not cut wide enough to provide enough coverage. In order to compensate for the lack of copper sheathing on the sides, a small fragment of copper sheet (fig. 5-41, GT 3169 C) was placed at the bottom port side of the sternpost between both the copper layers. This small fragment of copper sheathing measures 7.8 cm in length, 7 cm in width, and 3 mm in thickness.

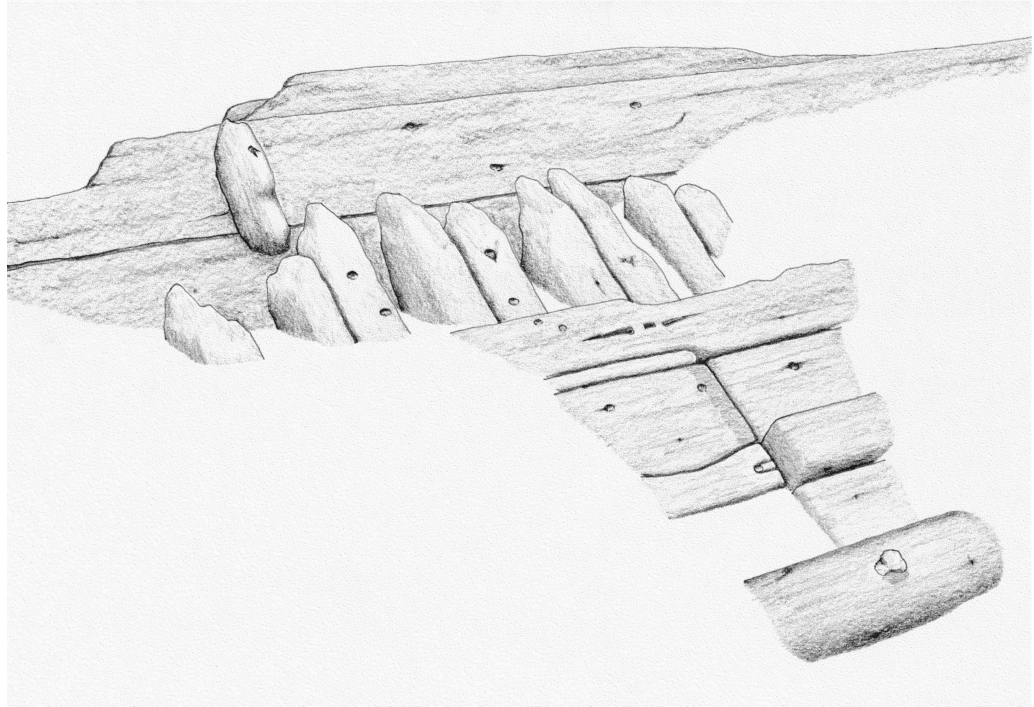
FIGURE 5-42.
Port-side bottom of
Avondster's amidships.
From Murray,
"Interpretation of the
Anglo-Dutch East-
Indiaman *Avondster*
Ship's Construction,"
fig. 9.6.

centerline varies from 10 to 33 cm. No molded dimensions were taken, but Murray does mention that the layers of hull planking and sheathing were thicker than the frames. A few wood samples from the frames have been identified as oak.¹²⁹ A positive identification of the individual frame timbers and their assembly, however, cannot be made because they are covered by ceiling planking and, on the ship's port side, the keelson. Murray suggests that the ship was constructed with double frames, a practice that came into use much later, sometime in the third quarter of the seventeenth century, for the construction of English men-of-war (*Avondster* was a merchant vessel built half a century earlier).¹³⁰ Murray exemplifies his hypothesis with a drawing of the port-side frame timbers, which he earlier suggested possibly compose paired floors and futtocks (fig. 5-42). The drawing may, however, simply show standard frame timbers with floor timber heads and futtock heels exposed underwater.

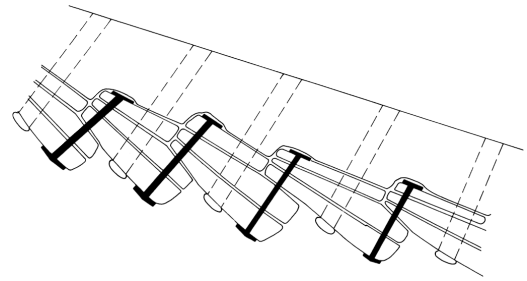
FIGURE 6-1. Reconstruction drawing of the triple layer of hull planking of the R. Hamble wreck at Buresdon, or Henry V's *Grace Dieu* of 1418. Illustration from Clarke et al., "Recent Work on the R. Hamble Wreck," fig. 5.

Three layers of planking that make up each of *Grace Dieu*'s planking strakes are fastened together with small nails to form one thick composite plank.⁴³ This, however, conceptually differs from the Dutch-built ships, in which the second layer of hull planking was not added to the first layer before they were erected but much later in the construction process (after the frames were installed). The inner layer of the Buresdon ship's composite planking was about 4 in (0.102 m) narrower at its bottom than the two outer ones. The two wider layers of this strake overlapped the three planks of the strake below and were fastened to it with iron nails riveted over roves (fig. 6-1).⁴⁴ Thus, the overlap of the planking strakes consisted of five layers of planking. After the planking was assembled, the ship's joggled frames were installed and fastened to the thick triple planking strakes with wooden treenails.⁴⁵ For the construction of *Grace Dieu* and its attending vessels 3,906 trees were felled, including 2,735 oaks and 1,171 pine, ash, and elm trees.⁴⁶

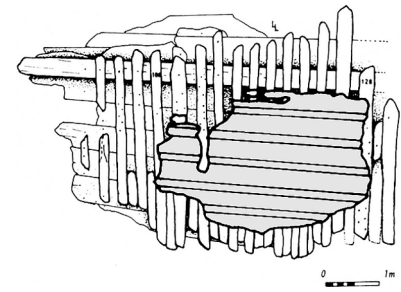
FIGURE 6-2. The ceiling planking between frames 106 and 128, VOC ship *Mauritius*. Illustration by Michel Rival, in L'Hour, Long, and Rieth, *Le Mauritius*, 214. © CASTERMAN S.A.

Furthermore, the 12 strakes of ceiling planking of *Batavia* cover the entire preserved stern side of the ship (above the bilges). The ceiling planking varies from 0.06 to 0.07 m in thickness at the ship's bottom and from 0.08 to 0.09 m at the sides. The ceiling planking found on *Mauritius* is located at the bottom of the ship's hold next to the keel between frames 106 and 128 and is treenailed to the frames, presumably the floors (fig. 6-2).⁵⁵ It has an average thickness of 0.08 m, and the width of the ceiling planks varies from 0.30 to 0.55 m.⁵⁶ Its thickness is equal to that of one layer of hull planking and must have added significant strength to the ship's hull. The hull remains of *Mauritius* are, however, insufficient to conclude whether or not the ceiling planking extended beyond the bilges.

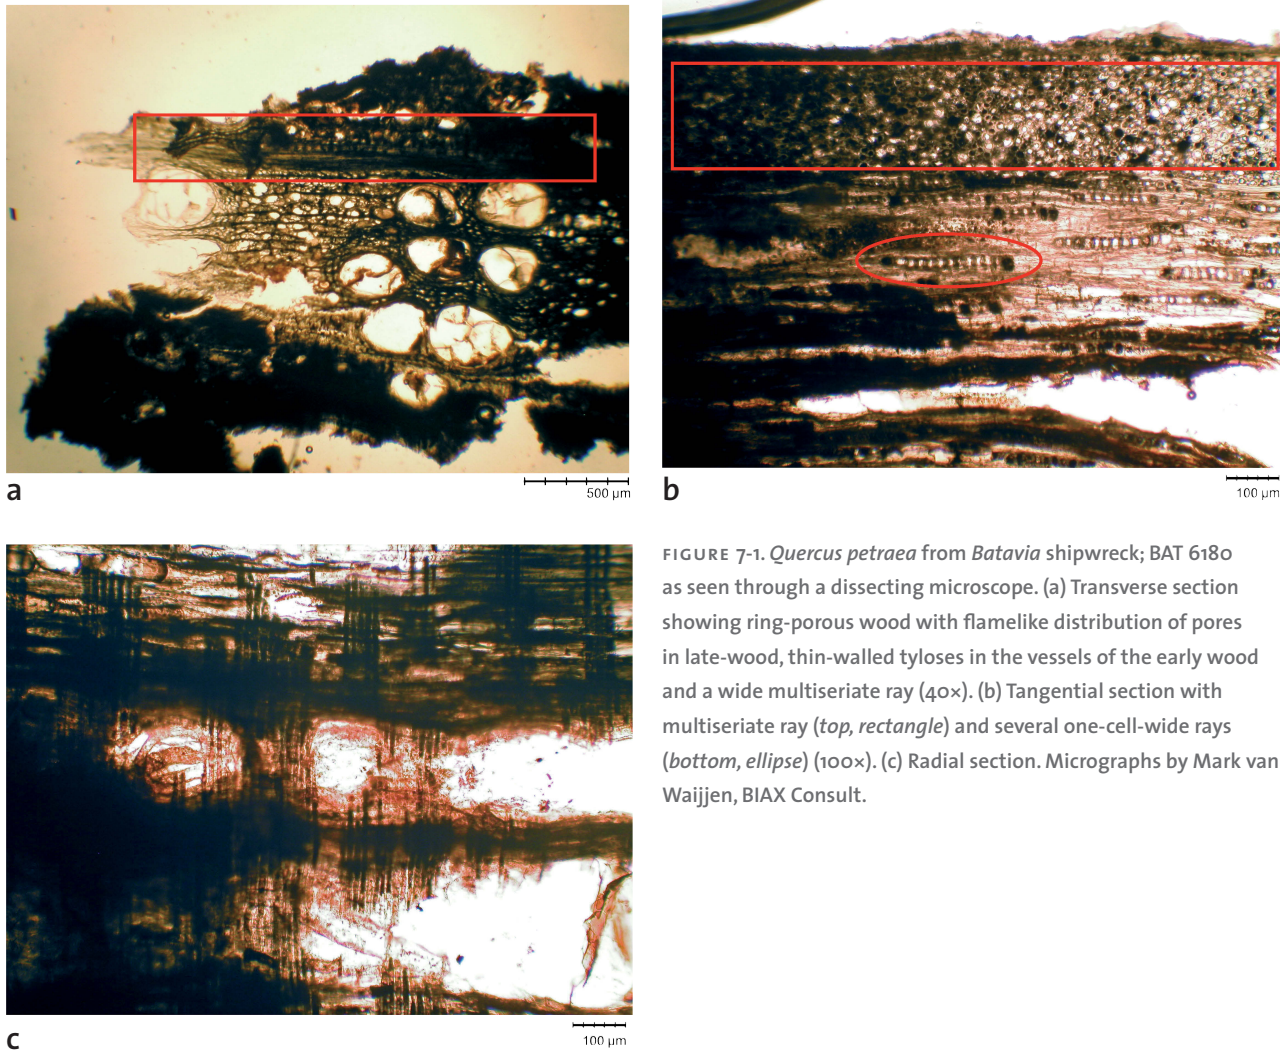
FIGURE 7-1. *Quercus petraea* from *Batavia* shipwreck; BAT 6180 as seen through a dissecting microscope. (a) Transverse section showing ring-porous wood with flamelike distribution of pores in late-wood, thin-walled tyloses in the vessels of the early wood and a wide multiseriate ray (40×). (b) Tangential section with multiseriate ray (top, rectangle) and several one-cell-wide rays (bottom, ellipse) (100×). (c) Radial section. Micrographs by Mark van Waijjen, BIAx Consult.

Twenty-two *Batavia* timbers have been sampled and analyzed for wood species identification.¹⁸ The results have shown that at least two different genera of wood were used in the construction of the ship; all structural timbers, such as the planking, frames, ceiling planking, treenails, and beams, were made of oak, *Quercus* sp. (fig. 7-1; tables 7-1 and 7-2). The oak is either *Q. robur* (pedunculate oak) or *Q. petraea* (sessile oak); the wood of these two species can be distinguished based on their anatomical characteristics, and both species were identified among *Batavia* timbers.¹⁹ The differences between *Q. robur* and *Q. petraea*, even if minute, are expressed in the distribution pattern of the small tracheids produced during the mid- and late growth season, after the large-diameter tracheids had formed in a ring shape at the beginning of the growth season.²⁰

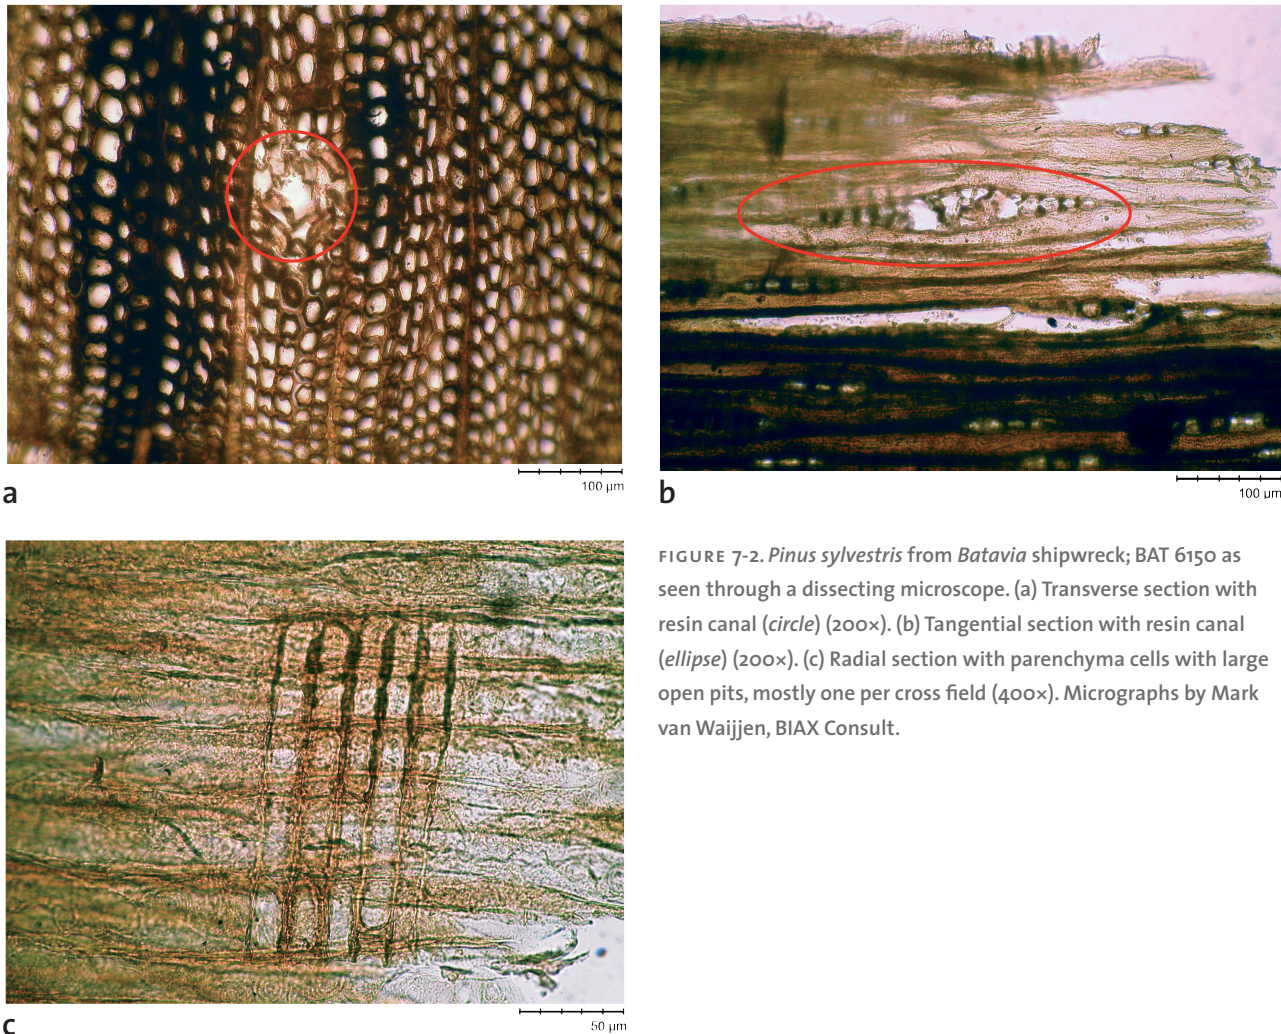
FIGURE 7-2. *Pinus sylvestris* from *Batavia* shipwreck; BAT 6150 as seen through a dissecting microscope. (a) Transverse section with resin canal (*circle*) (200×). (b) Tangential section with resin canal (*ellipse*) (200×). (c) Radial section with parenchyma cells with large open pits, mostly one per cross field (400×). Micrographs by Mark van Waijjen, BIAAX Consult.

The sacrificial planking or sheathing of *Batavia*'s hull and the floor on top of its ceiling planking were made of pine, most likely *Pinus sylvestris* (fig. 7-2; table 7-2). Anatomically, no differentiation could be made in the past between *Pinus sylvestris* (Scots pine) and *P. mugo* (mountain pine), but the latter is a dwarf shrub variety not suitable for shipbuilding and therefore unlikely.²¹ However, most recently wood identification of three samples of *Batavia* sheathing confirmed the use of *P. sylvestris*.²²

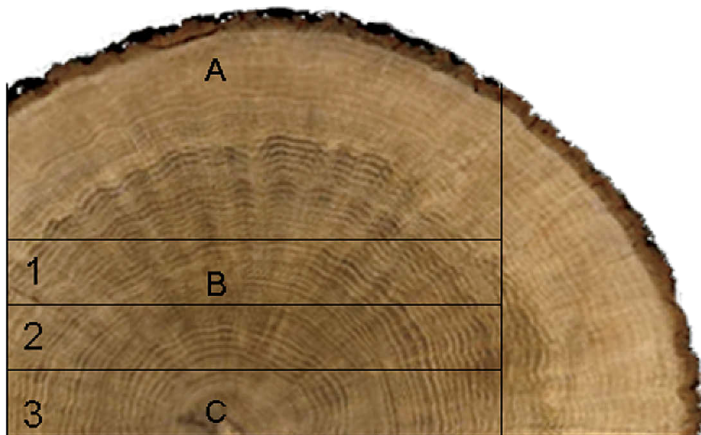
FIGURE 7-3.
Cross section of oak tree with
sapwood (A), heartwood (B),
and pith (C). Photograph by
author.

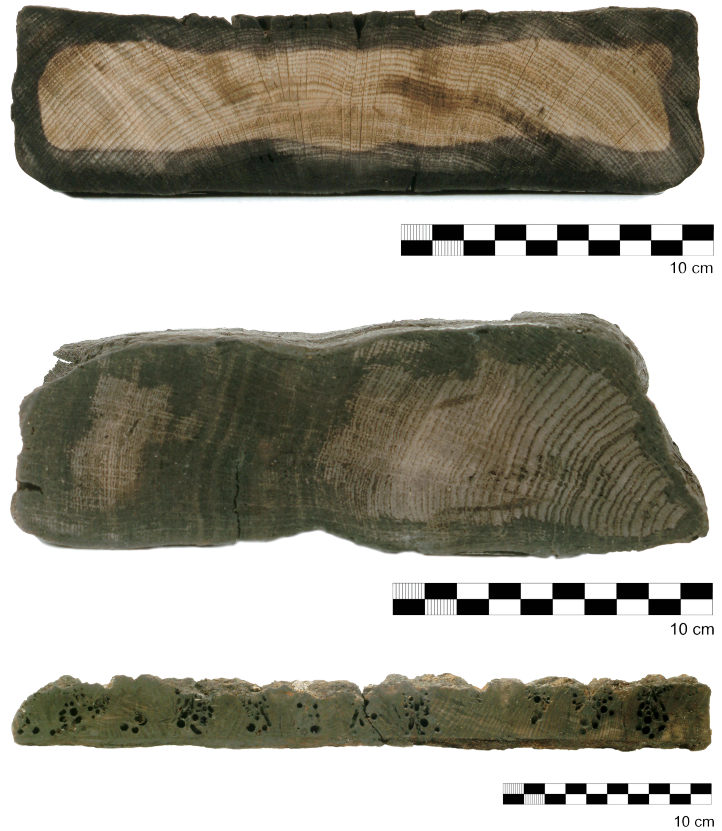
FIGURE 7-4.
Cross sections of
tangentially sawn oak hull
planks from *Batavia* for
dendrochronological study.
Photographs by Patrick Baker,
Western Australian Museum.

The manufacturing process itself (sawing planks from the timber) easily removed all sapwood and possibly some heartwood growth rings. Planks and sheathing were sawn from halves of logs of approximately the same diameter that were split over their entire length. After the bark and sapwood were removed, the tapering sides were taken off and the timber sawn plain or tangentially into planks (fig. 7-3). All planks of *Batavia* sampled for dendrochronological study were sawn according to this method (fig. 7-4). This manner of sawing can easily be recognized by the pattern of semicircular tree rings in the grain visible at the ends of the planks. Hull plank BAT 6375 could, however, be slightly misleading to the untrained eye, as it is broken into two sections over its pith. Plain- or tangential-sawn timber also tends to cup more over time than quartered or radial-sawn lumber.

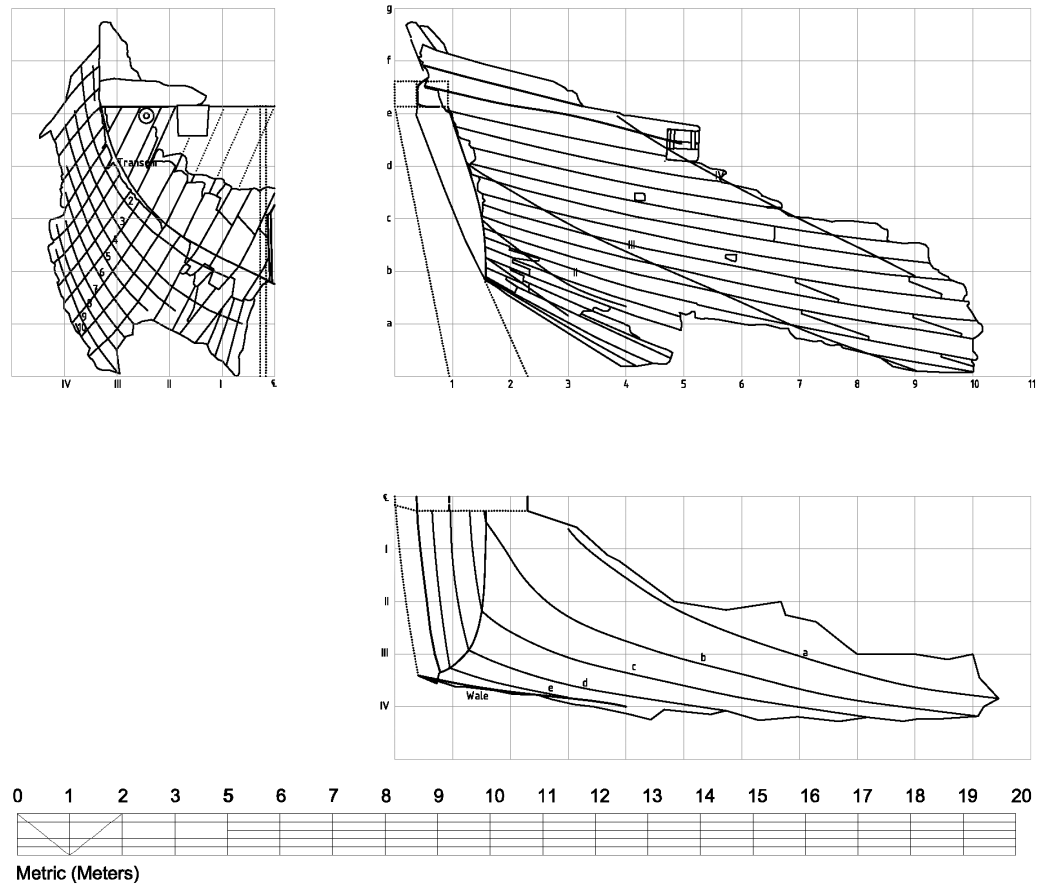
FIGURE 8-1.
Lines plan of *Batavia*'s
preserved hull section.
The lines were taken off
the exterior of the ship,
thus on the outside
of the hull planking.
Illustration by Cor Emke.

From the waterline markings on *Batavia*'s sternpost one can calculate that 4.10 m are missing from the sternpost's lower end, whereas the upper edge of the wing transom marks the top of the sternpost. When these two factors and the angle of the sternpost are taken into consideration, it is estimated that the linear or vertical height of the sternpost was 25.5 Amsterdam ft (7.20 m). The sided dimension of *Batavia*'s sternpost more or less corresponds with Witsen's suggestion that the thickness (sided) dimension of the sternpost had to be 1 thumb for every 10 ft of the ship's length. For *Batavia*, this would have been 16 Amsterdam thumbs.

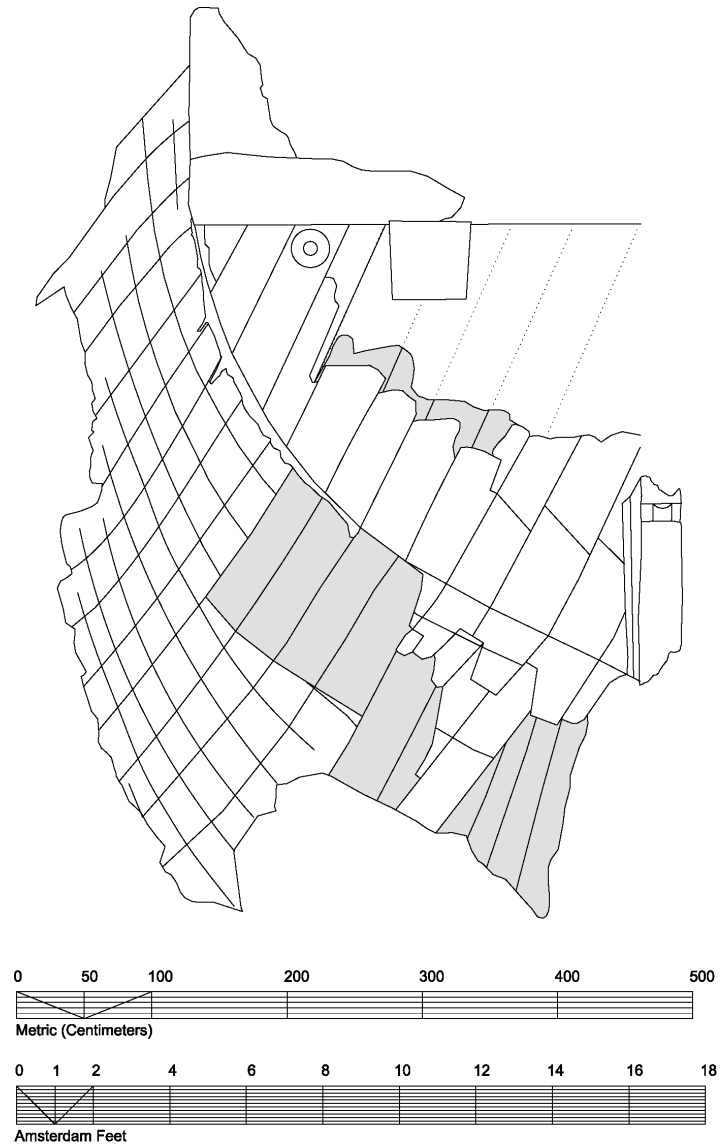
FIGURE 8-2.
Preserved port-side transom
of *Batavia* showing the section
lines of the body plan. Gray-
colored planks represent the
inner layer of hull planking
where the outer layer has
eroded away. Illustration by
author.

Batavia's garboard strake and adjacent lowest planking strakes have not survived. On the port side, the remaining hull strakes from the ship's bottom include preserved strakes 1–12, extending from the flat bottom to above the turn of the bilge. The inner layer of hull planking was first assembled in a shell-based method up to strake 12. The plank ends of this layer were scarfed with flat scarfs that were not evenly spread over the ship's lower hull, as demonstrated by the concentration of seven flat scarfs in the forward end of the preserved section. According to the 1603 charter for a large ship, the hull and ceiling were to be made of “eastern” or oak planks that were one-quarter of an Amsterdam ft (7.1 cm) in thickness. It is also specifically mentioned that this thickness depended on the quality of the wood “being soundly flawless.” The planking thickness recommended in the 1603 charter applied to the inner layer of hull planking, as the outer layer, for which
